**Report on Explosion and Fire
at Regent Oil Co. Ltd. premises
Avonmouth, Bristol
on 7th September 1951**

REPORT ON
EXPLOSION AND FIRE AT
REGENT OIL CO. LTD. PREMISES
ROYAL EDWARD DOCK
AVONMOUTH, BRISTOL
ON 7th SEPTEMBER,
1951

H. E. WATTS, C.B., M.B.E., G.M., Ph.D., B.Sc. F.R.I.C.,

H.M. Chief Inspector of Explosives

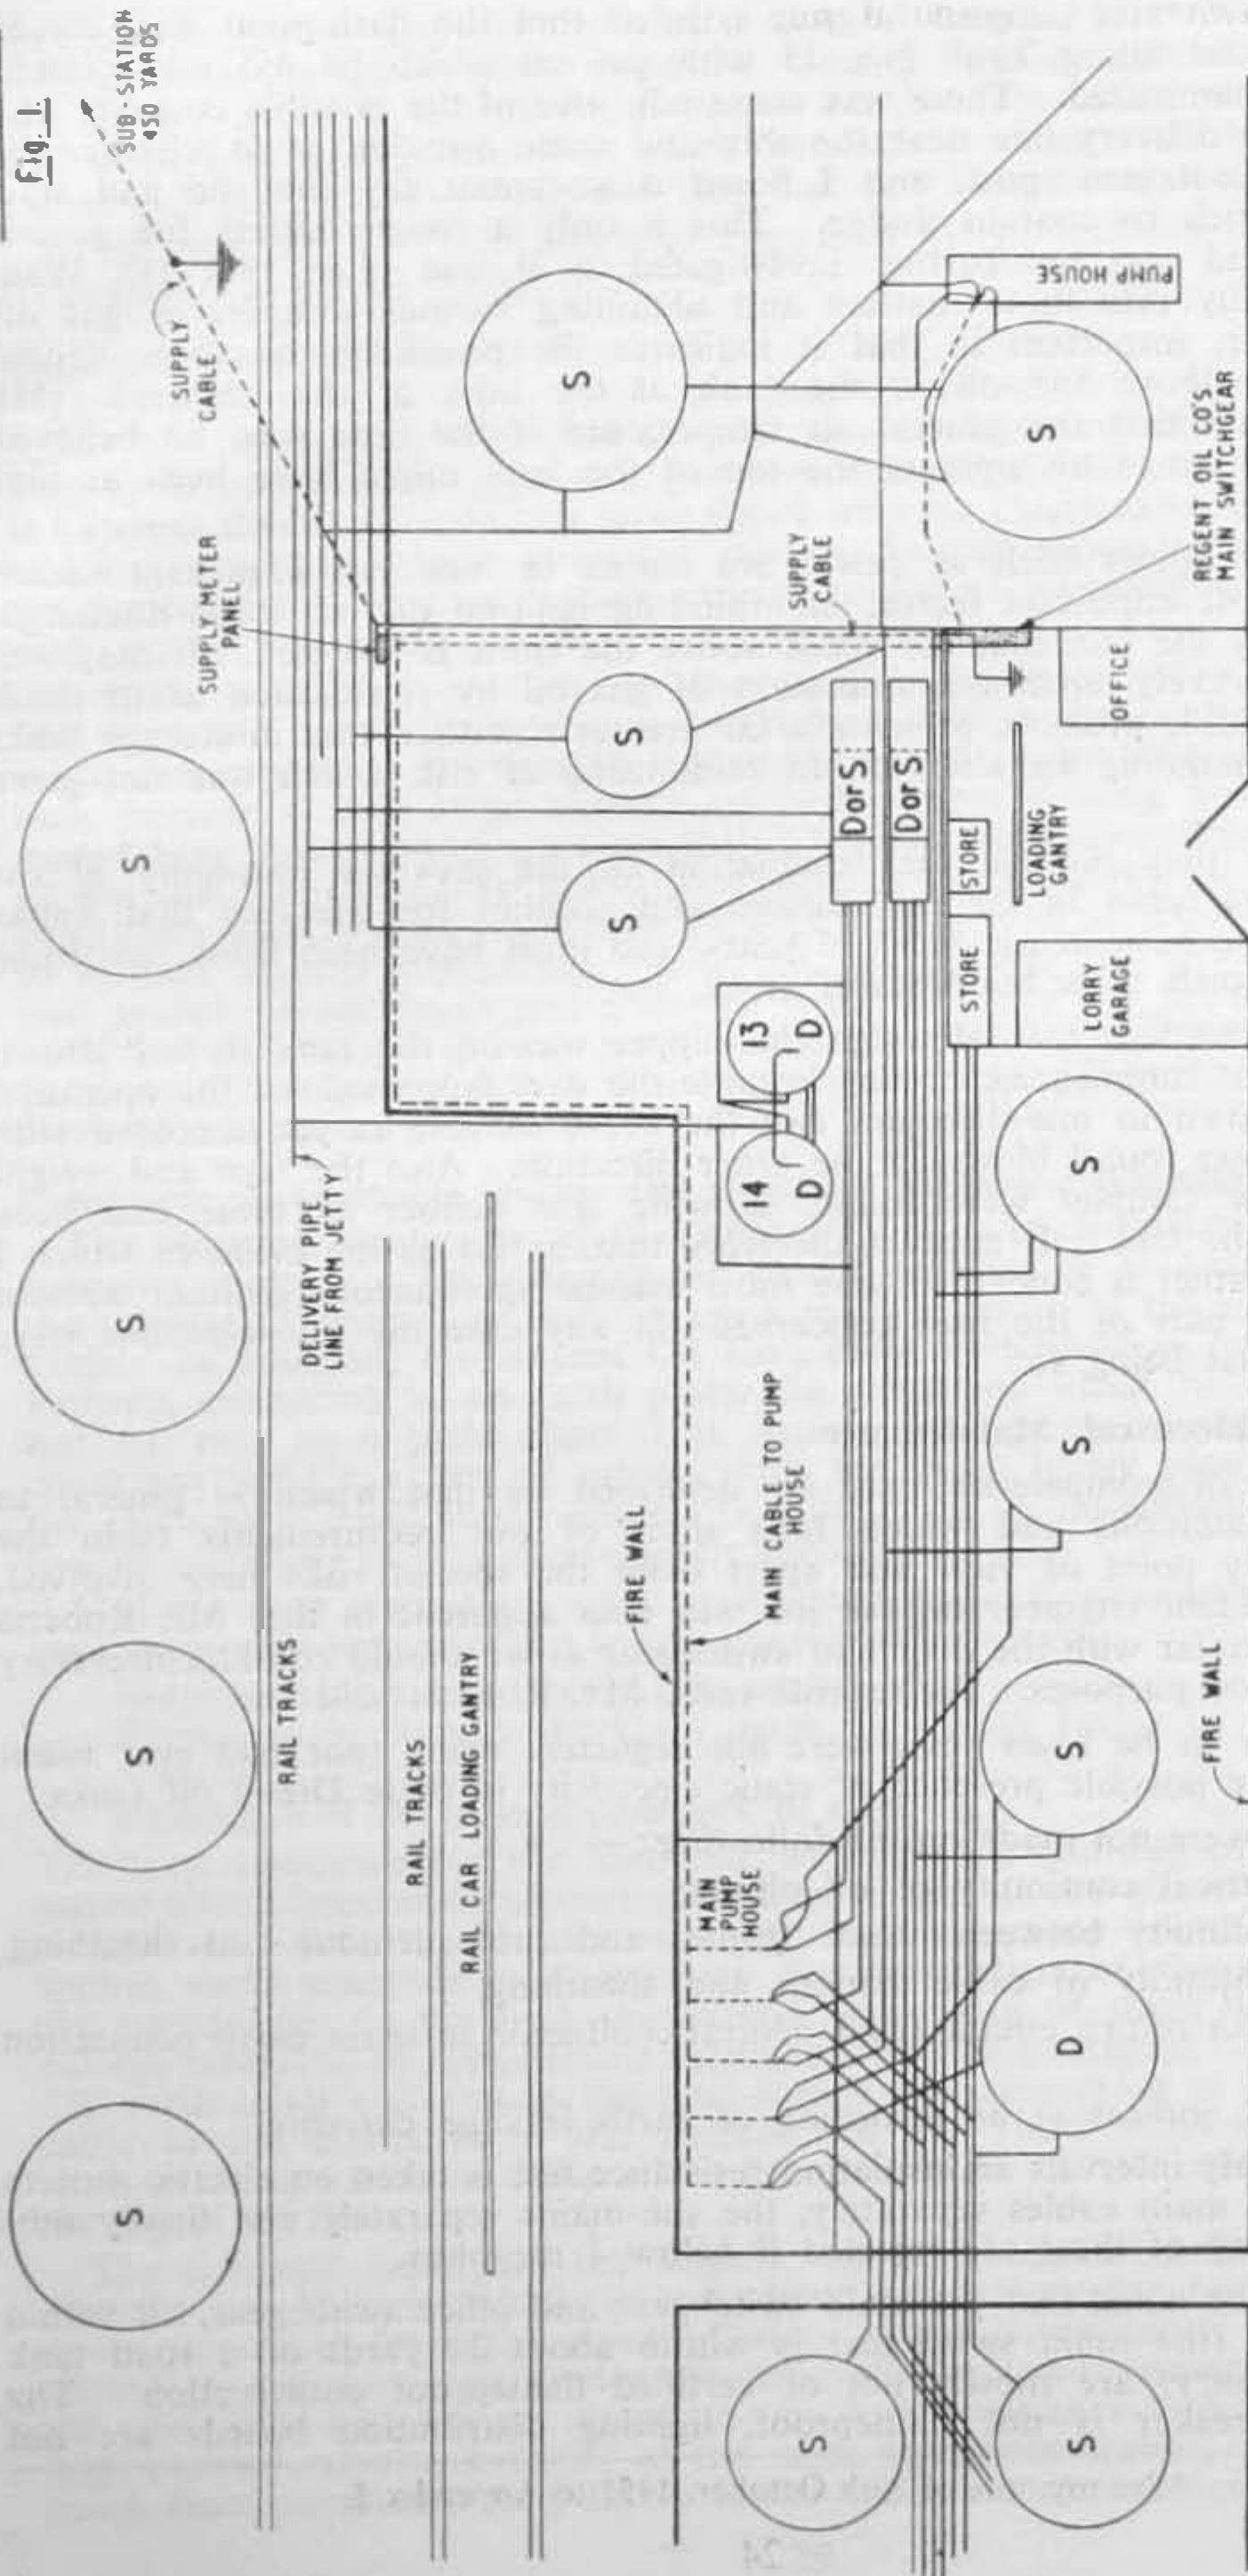
Fig. 1.

The fire occurred in the walled compound which was the original storage installation and which has since been extended by the addition of other compounds, one at each end and one on one side (see Fig. 1). The fire in this compound destroyed or damaged almost everything within it, but by virtue of the wall, good work on the part of the Fire Brigade and good fortune with the winds, was prevented from extending to the remainder of the installation.

Tank No. 13 was seat of fire.

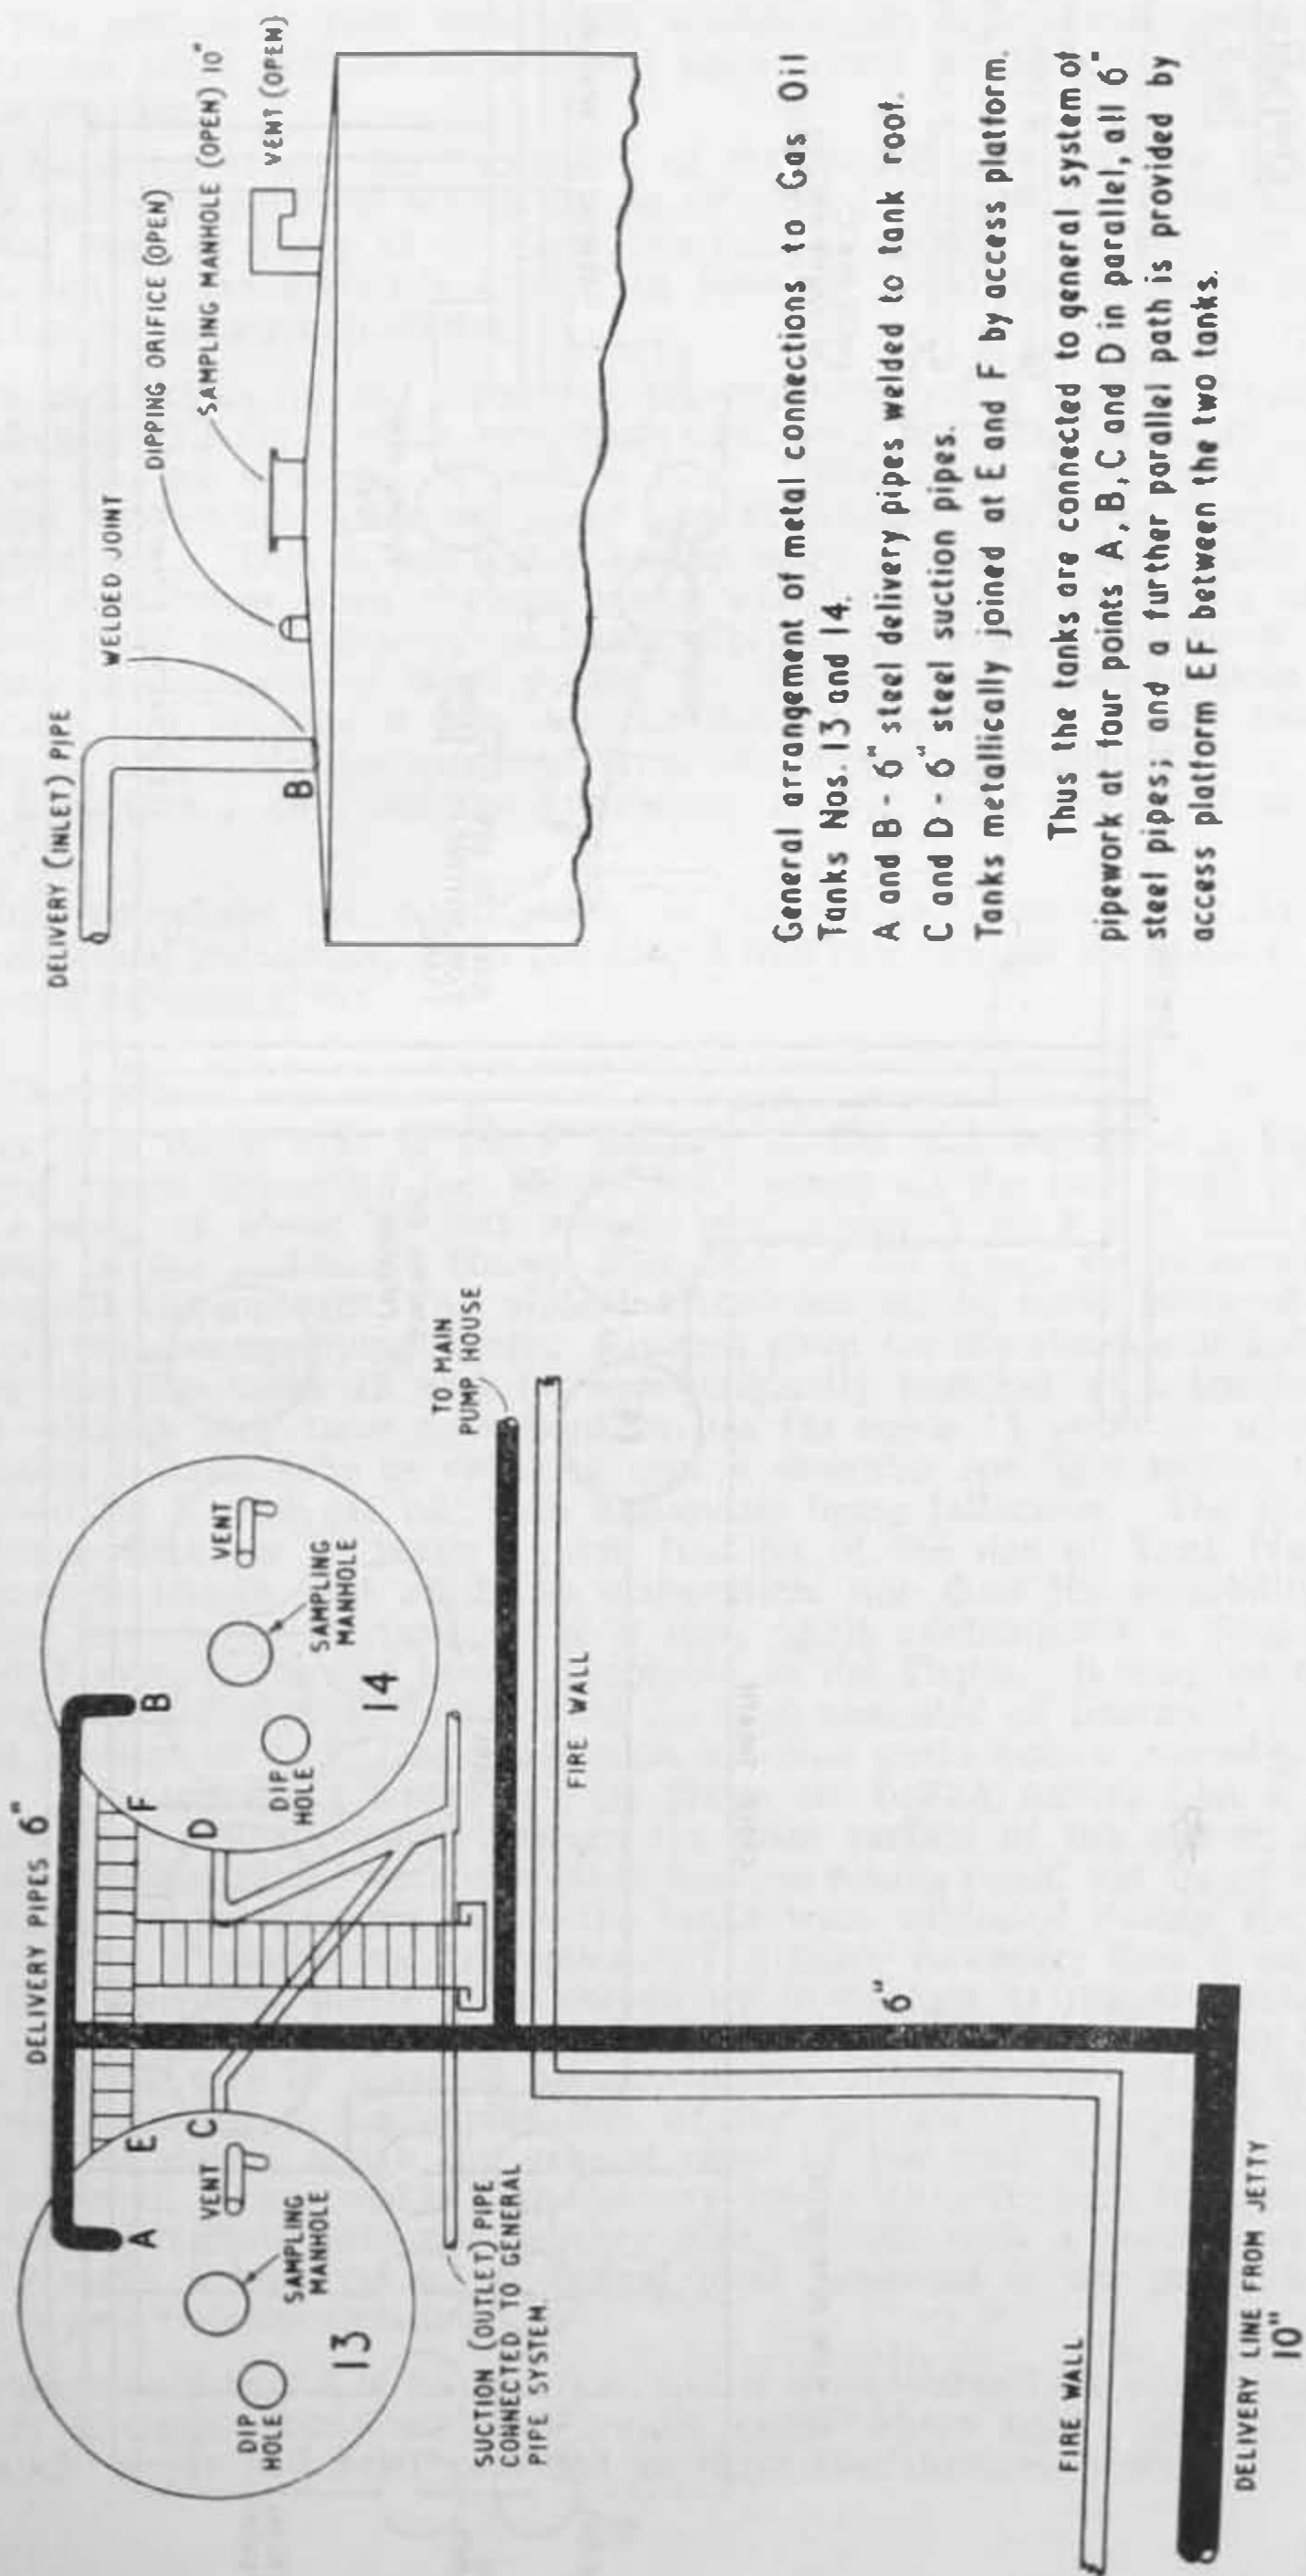
Fig. 2.

General arrangement of metal connections to Gas Oil Tanks Nos. 13 and 14.

Thus the tanks are connected to general system of pipework at four points A, B, C and D in parallel, all 6" steel pipes; and a further parallel path is provided by access platform EF between the two tanks.

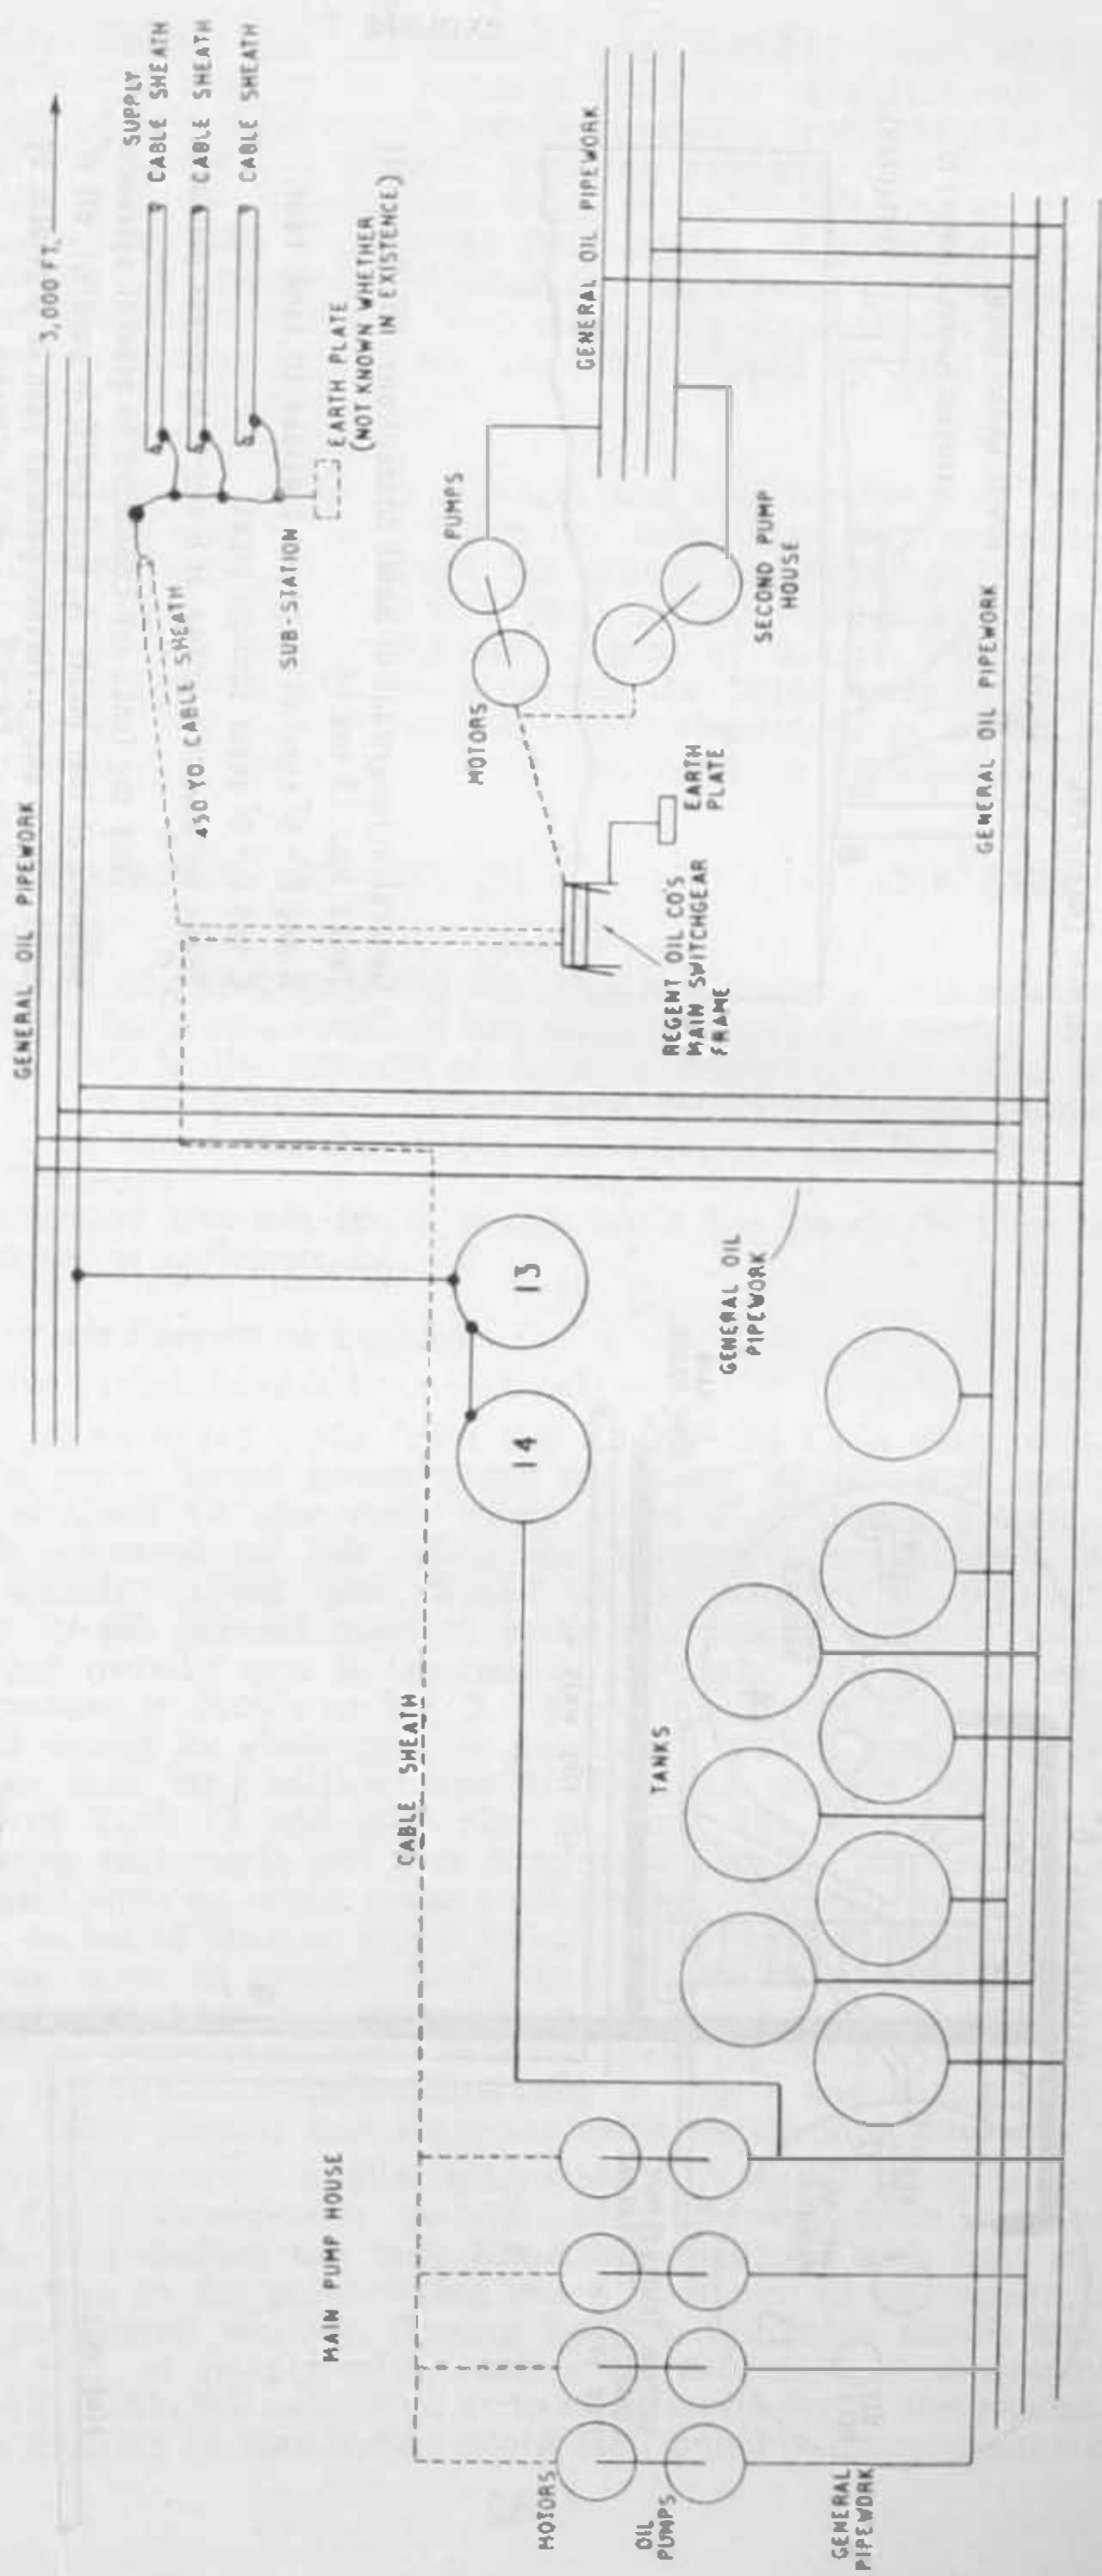
APPENDIX 5.
Fig. 3.

General Schematic Arrangement of Earthing System, showing how Regent Oil Co's earthing conductors (cable sheaths—dotted) are tied at substation with other feeder cable sheaths and via their own motors and pumps with the general pipework of the depot. The result is an extremely "solid" earth network.

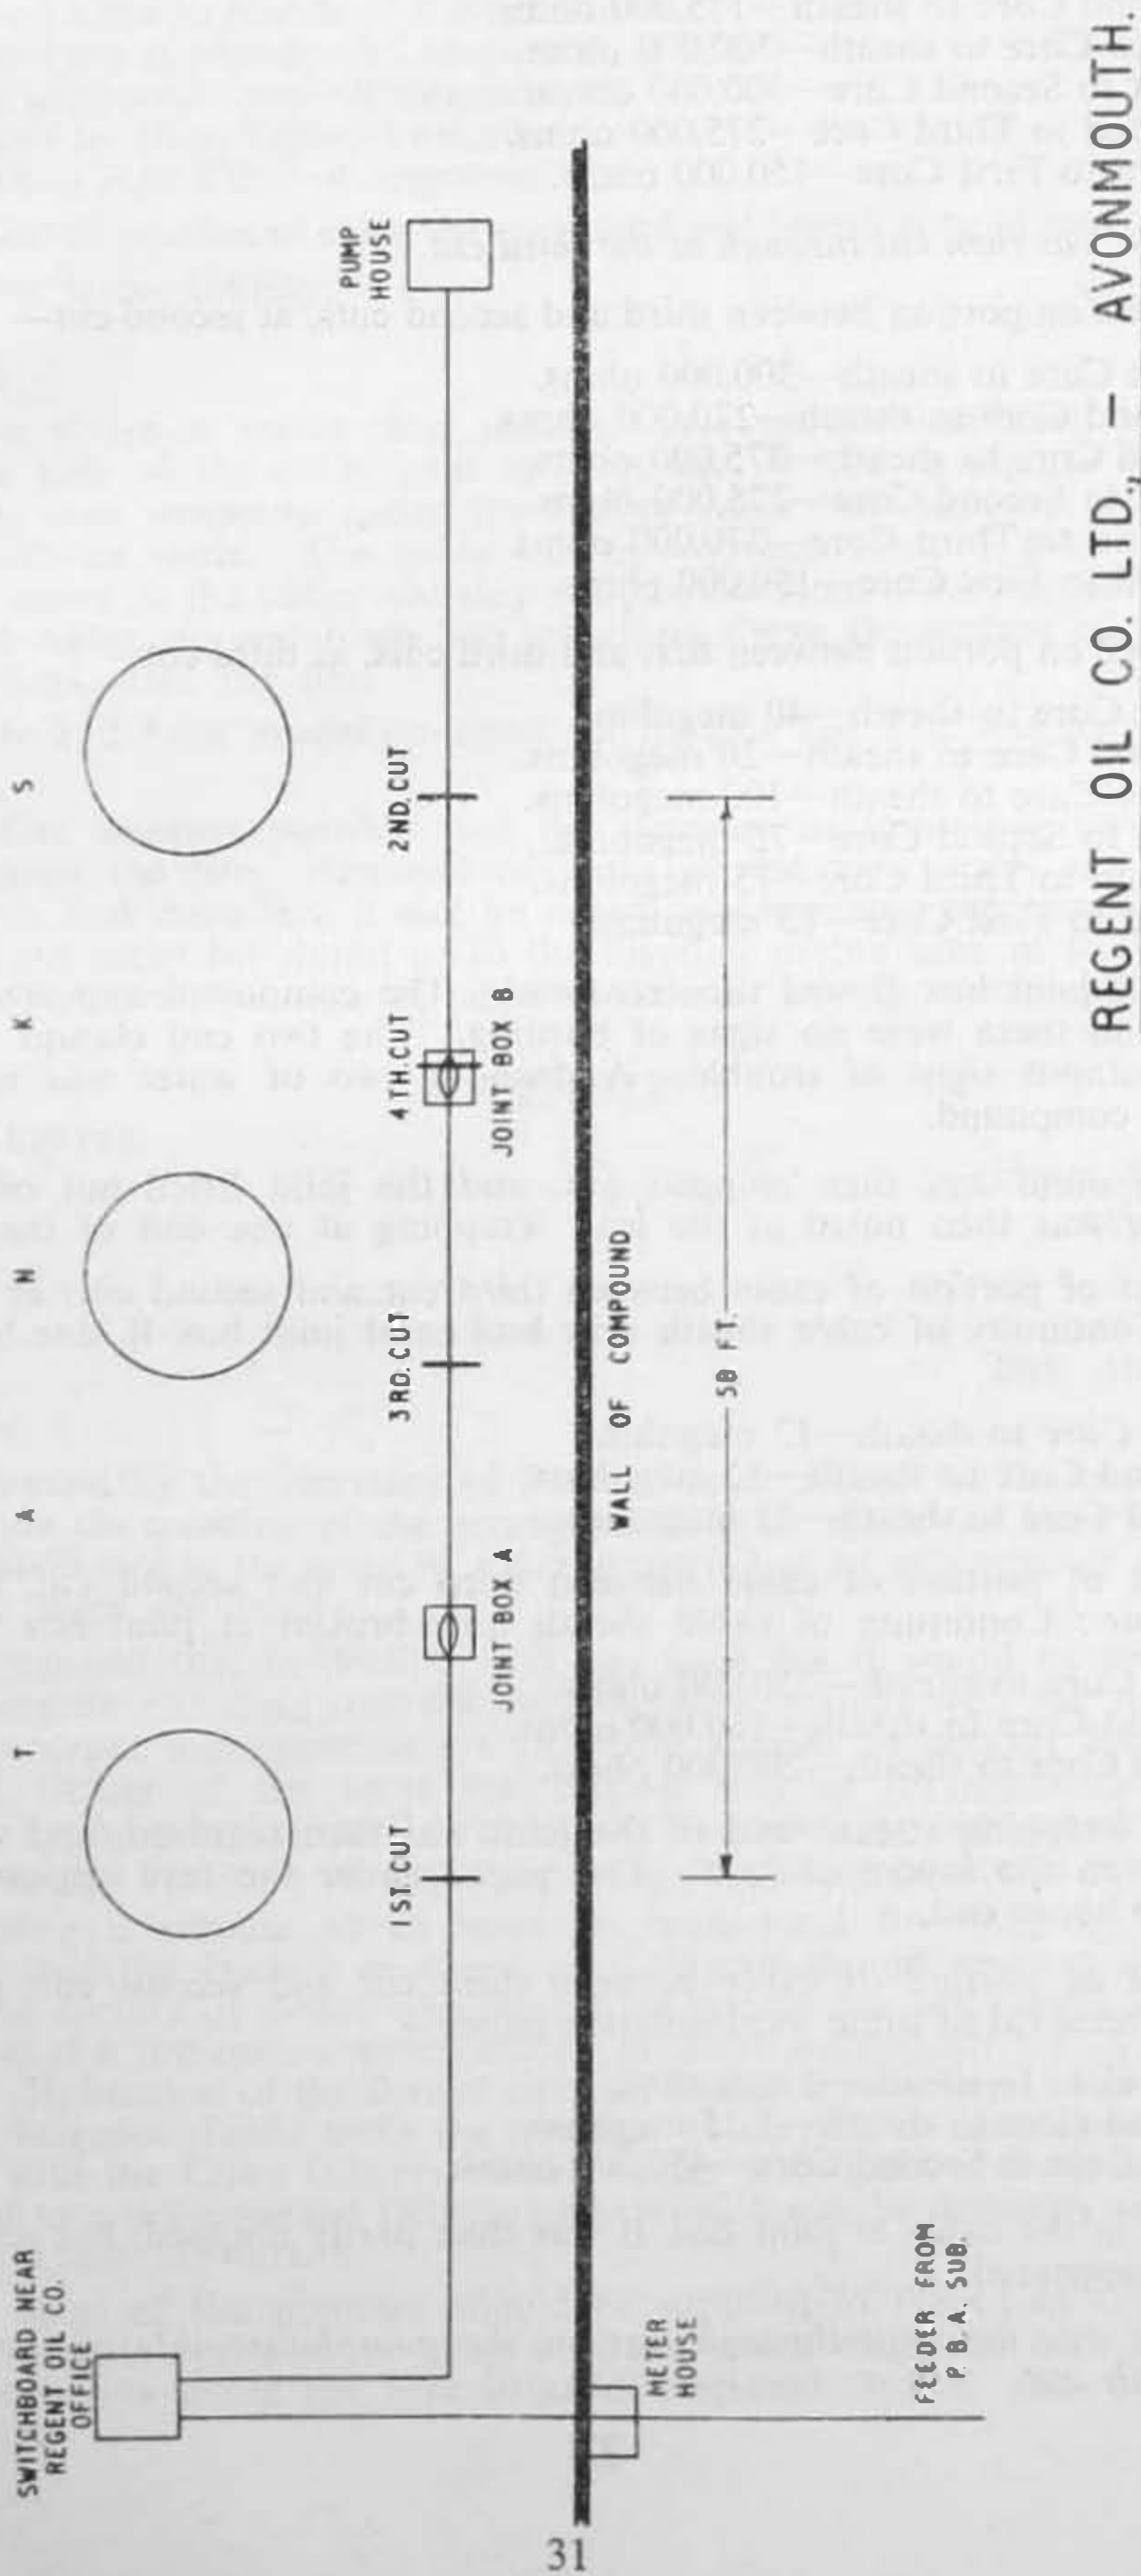
Fig. 4.

"A sketch (Fig. 4) shows the layout. The piece of cable between the two joint boxes was inserted to replace a damaged portion of the original cable about six years ago.

The inspection and tests proved, in my opinion, that no fault occurred in this cable. The insulation values at joint box B were low, and some water was found in the lead wrapping and paper insulation at the end of the box near the pumphouse. The compound and all other installation were, however, in excellent condition, and no signs of burning, puncture or flashover were seen.
